Manhole Inspection Summary

Manhole # S15E__015MH

Insp Date: **1/6/09 10:20 AM**

Location Address: **239 FRANKLINTOWN RD**

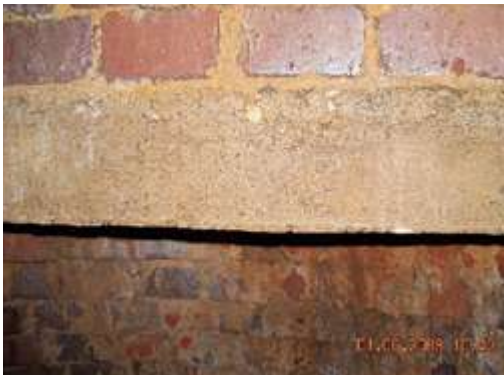
CONCRETE SLAB

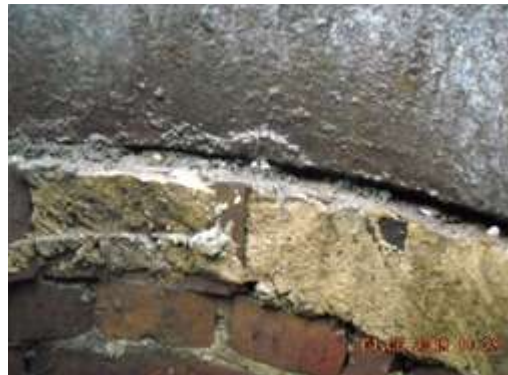
Defect 5

CONCRETE SLAB ABOVE O12

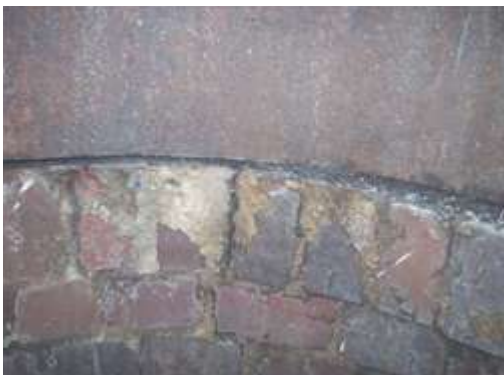
Defect 2

CHIMNEY ADJUSTMENT OF 3"

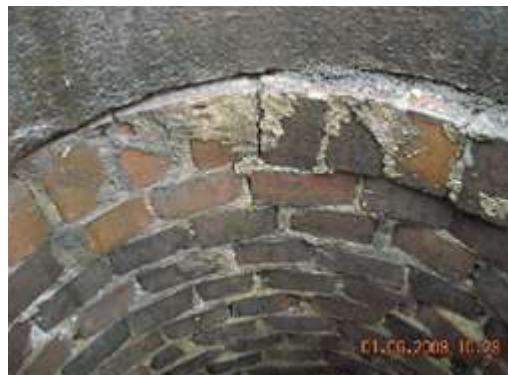
Defect 4

Condition: ☐ Sound ☒ **Cracked** ☐ Root Intrusion ☐ Loose Brick ☐ Deteriorated

Infiltration: ☐ None ☐ Joint ☐ Cracks ☒ **Mortar** ☐ Roots ☐ Wall

SMALL CRACK IN CHIMNEY WITH INFILTRATION COMING FROM THE MORTAR

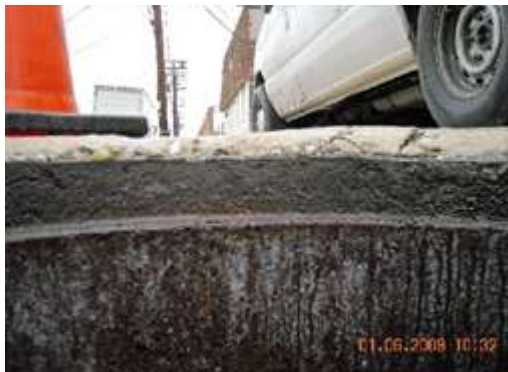
Defect 6

CRACK IN CHIMNEY WALL

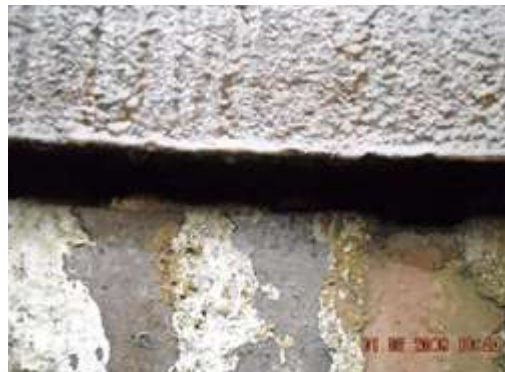
Defect 7

FRAME SITS 1" BELOW GRADE

1" GAP BELOW FRAME

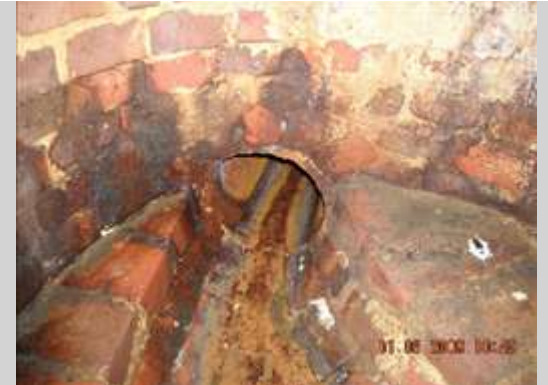
12 O'Clock Outflow

Pipe Height: **8.4** (in.) Rod and Bar (Angled)
Pipe Material: **Clay** ☐ Pipe Lined
Invert Depth: **10.77** (ft.) Flow Characteristics: **Slow**
Deposits: ☒ None ☐ Mud ☐ Sludge ☐ **Debris** ☐ Grease
Silt Depth: (in.) Deposits Extent:
Infiltration: **None** Pipe Seal Cond: **Sound**

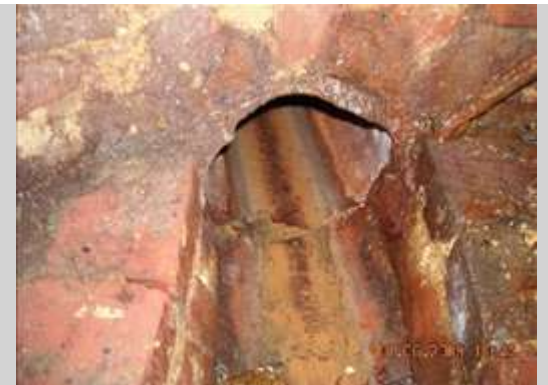
4 O'Clock Inflow

1" GAP BELOW FRAME

Pipe Height: **8.4** (in.) Rod and Bar (Angled)
Pipe Material: **Clay** ☐ Pipe Lined
Invert Depth: **10.52** (ft.) Flow Characteristics: **Slow**
Deposits: ☒ None ☐ Mud ☐ Sludge ☐ **Debris** ☐ Grease
Silt Depth: (in.) Deposits Extent:
Infiltration: **None** Pipe Seal Cond: **Sound**

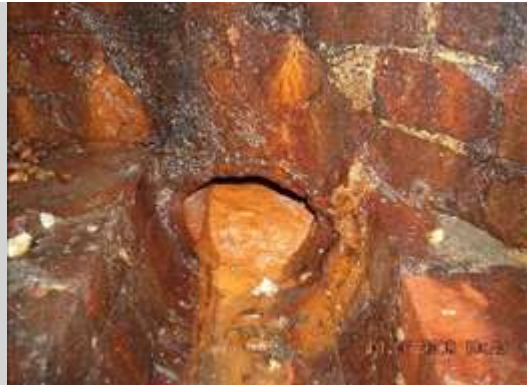
7 O'Clock Inflow

BROKEN CONNECTION POSSIBLE PIPE
COLLAPSE WITH DEBRIS AND EVIDENCE
OF INFILTRATION

Deposits: ☐ None ☐ Mud ☐ Sludge ☒ **Debris** ☐ Grease

Silt Depth: **2** (in.) Deposits Extent: **Light**

Infiltration: **Evidence** Pipe Seal Cond: **Broken**
